# THE BELT RAILWAY COMPANY OF CHICAGO

## MECHANICAL NOTICE #2019-005

**Subject:** Check List / Job Aid for Car Inspection

### ***Flat Car Side Handhold Arrangements***

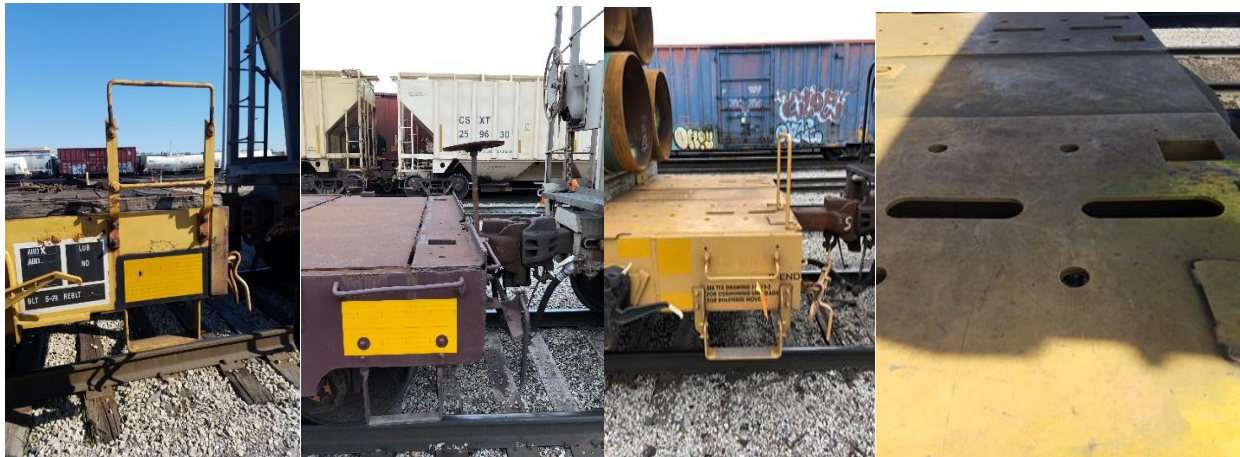
The above 4 pictures are examples of cars that are OK to move without repair

- Picture #1 sufficient ladder and grab irons
- Picture #2 end hand brake does not need additional ladder or grab irons on side of car
- Picture #3 and #4 vertical grab iron is OK as well as car has "grab holes" in floor. This is NOT a condition the FRA takes exception to.

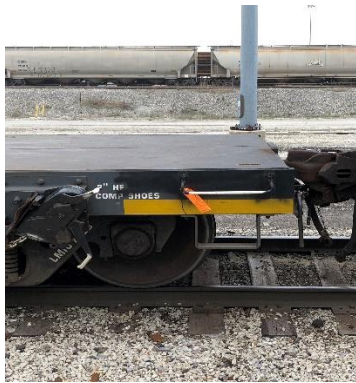
- This arrangement above needs to be repaired due to not having a vertical handhold above car body (proper repair would be add a grab iron above car or remove existing side handhold and add 2 rung ladder)

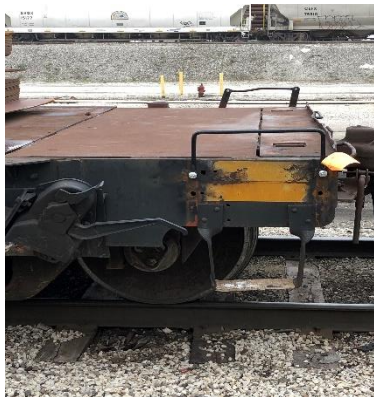
- This arrangement above needs to be repaired due to not having a side handhold on car (proper repair would be add a grab iron to side of car or remove existing handhold and add 2 rung ladder)
